## MECHANICAL PROPERTIES IN GTD-111 ALLOY IN HEAVY FRAME GAS TURBINES

**John R Scheibel**  
Electric Power Research Institute  
Palo Alto, California, USA

### ABSTRACT

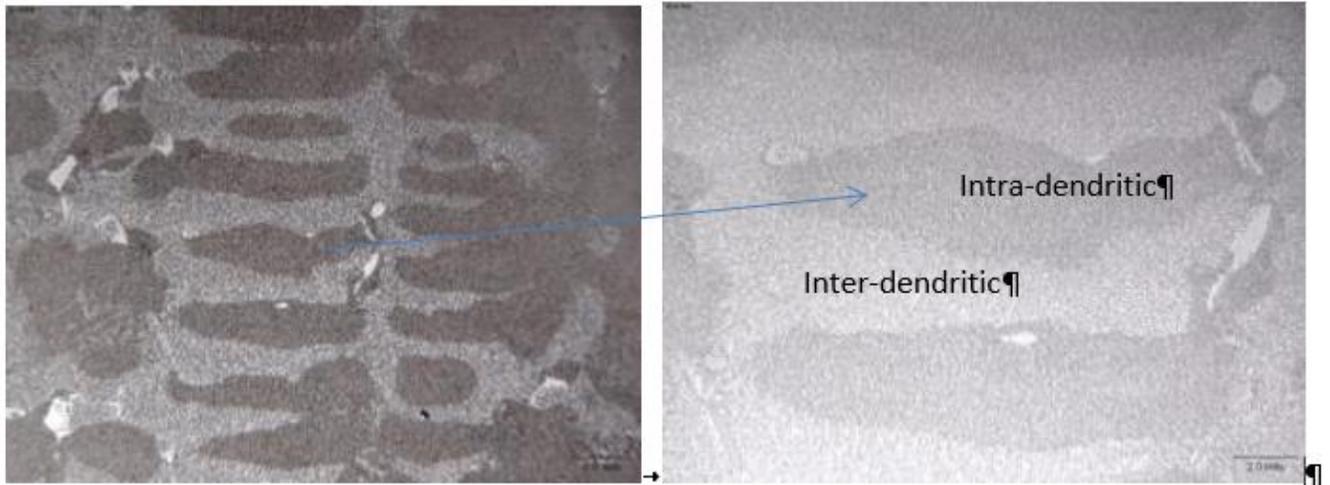
**Figure 3: Representative Micrograph Showing Inter-dendritic and Intra-dendritic Regions.**  
The picture on left shows dendritic microstructure and the one on right shows more detail on the difference in gamma-prime.

Scanning electron microscopy of the same sections was performed to study the gamma-prime morphology and distribution. Figure 3 provides representative detail on the inter-dendritic (outside the dendrite arm) and intra-dendritic (inside the dendrite) regions for reference. Figure 4 represents the microstructure of the bucket in as-run condition. The morphology appears to be different between inter-dendritic and intra-dendritic regions. The primary gamma prime of the inter-dendritic regions appear to be smaller and more cuboidal of shape than intra-dendritic regions. The size of gamma-prime was compared across different regions and the root section was assumed to be the baseline. The primary gamma prime at the TE was rounded and grown significantly (1.0 - 1.8  $\mu\text{m}$ , spherical), and the growth was somewhat less significant at the LE (0.7 - 1.2  $\mu\text{m}$ , spherical / rounded). At the mid airfoil cross and longitudinal sections, the size of the primary gamma prime (0.7 - 1.0  $\mu\text{m}$ , rounded) was just a little larger than the root (0.6 - 1.0  $\mu\text{m}$ , rounded / cuboidal) and maintained almost the same shape compared to the root. The secondary gamma prime was mostly not present at the TE, less present at the LE and about the same size (0.10 - 0.20  $\mu\text{m}$ ) and shape (spherical) at the mid airfoil and root.

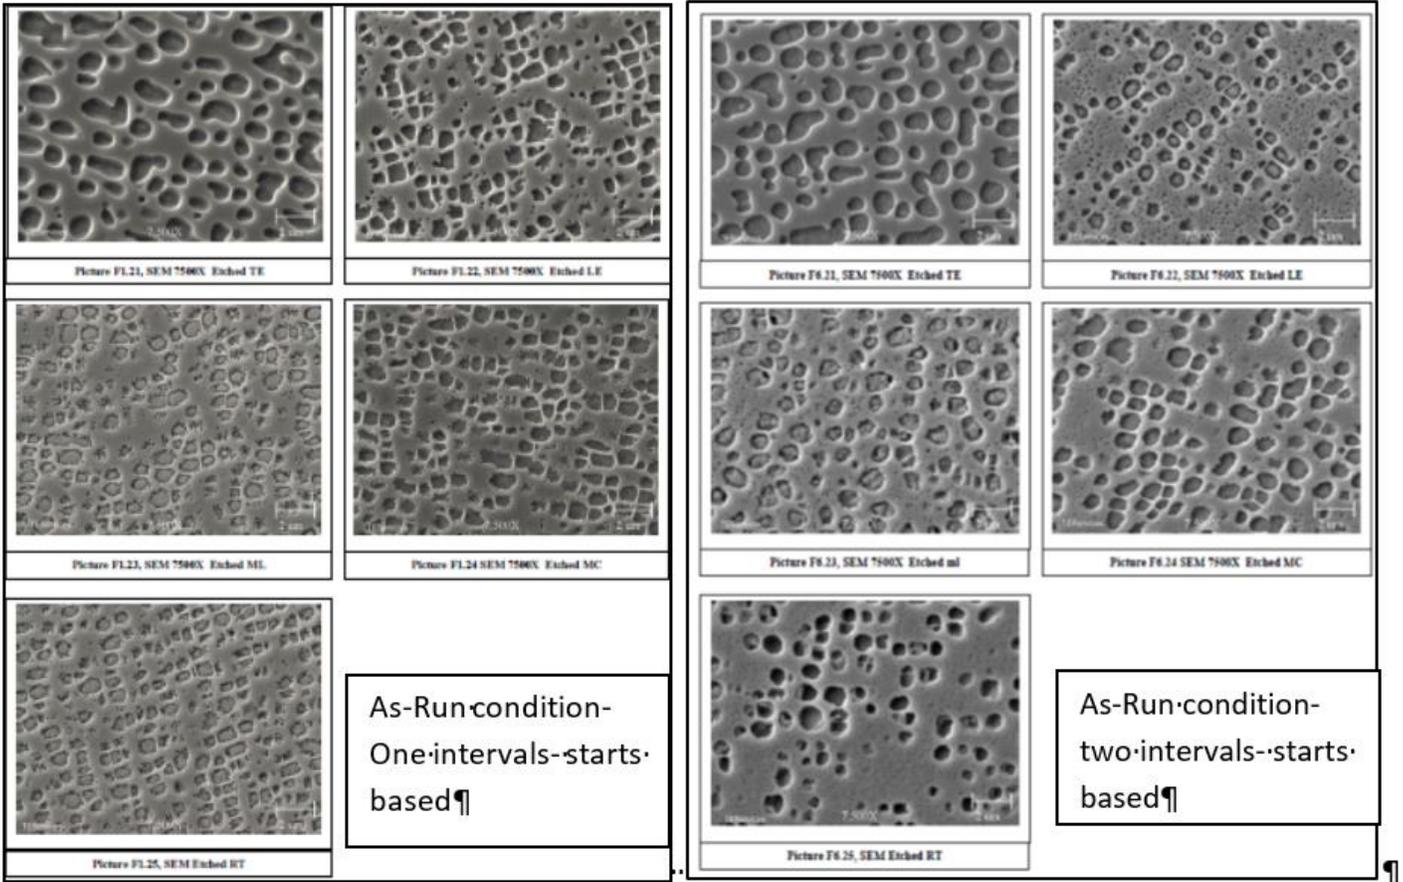
**Figure 4: Microstructure of the Specimens Extracted from Buckets after One Interval-starts based (on the left) and Two Intervals-starts based in As-run Condition (on the right)**

Scanning electron microscopy revealed that the primary gamma prime of the inter-dendritic regions was smaller and more cuboidal of shape than the intra-dendritic regions, similar to the one interval buckets. Figure 4 represents the microstructure of the bucket in as-run condition. The primary gamma prime had rounded in shape and grown significantly at the TE (1.2 - 1.8  $\mu\text{m}$  - spherical) and somewhat grown less significantly at the LE (0.8 - 1.2  $\mu\text{m}$  - rounded). At the mid airfoil, the primary gamma prime size (0.8 - 1.0  $\mu\text{m}$  - rounded), was just a little larger than at the root (0.8 - 0.9  $\mu\text{m}$  rounded) and maintained the same shape compared to the root. It needs to be noted that the relatively large size and rounded shape of the primary gamma prime at the root indicates that these buckets possibly did not receive the optimum HT's during the new manufacture or at the first repair. The secondary gamma prime was nearly not present at the TE and about the same size (0.10 - 0.20  $\mu\text{m}$ ) and shape (spherical) at the LE, mid airfoil and root. It needs to be noted that the volume fraction of secondary gamma prime at LE increased when compared to the first cycle buckets.

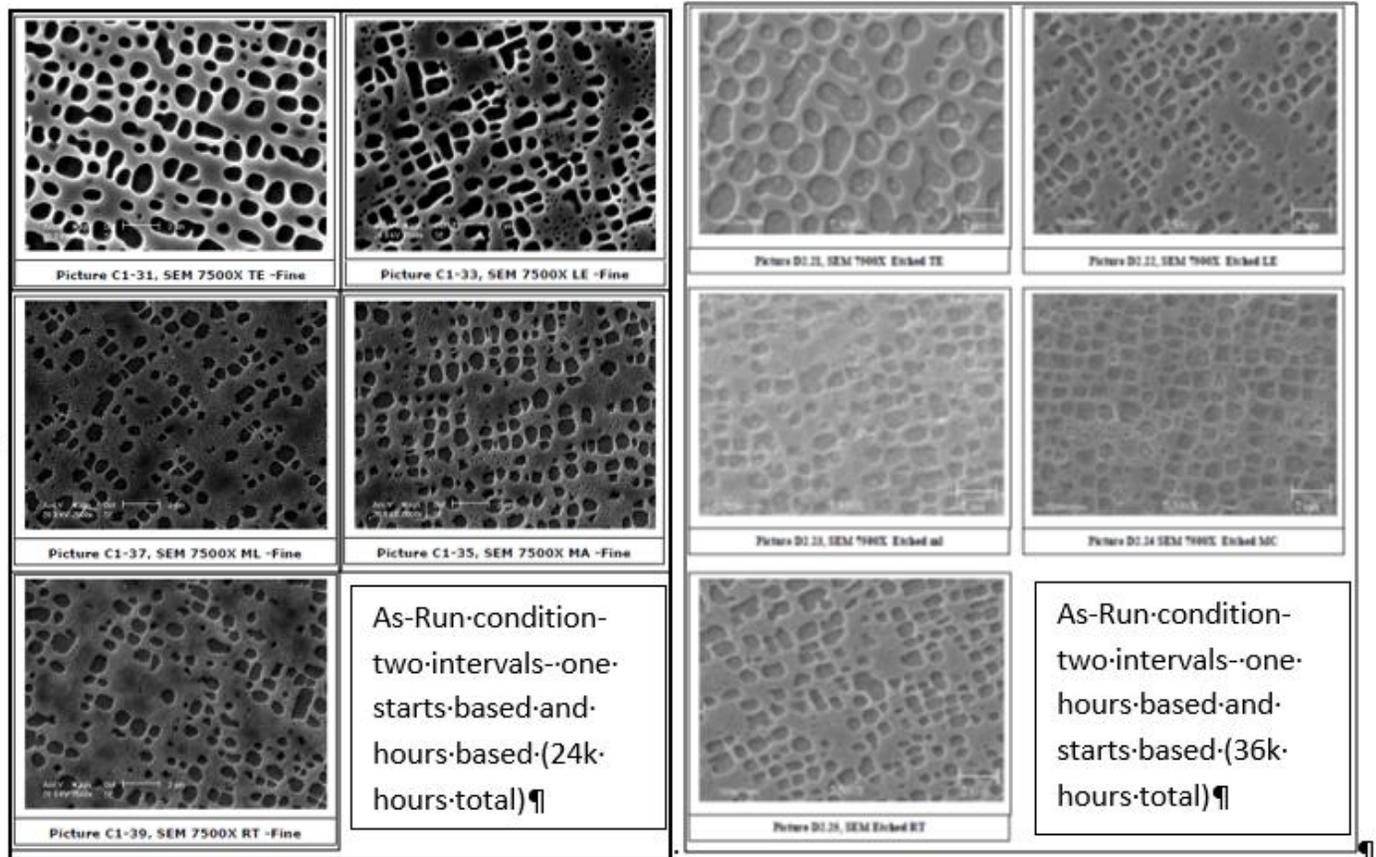
**Figure 5: Microstructure of the Specimens Extracted from Buckets after Two Intervals-one starts based and one hours based in As-run Condition [buckets accumulated 24k total hours on the left and the ones accumulated 36k total hours on the right]**

This section refers to the evaluation of the group of buckets that accumulated two service intervals with a repair after its first cycle. The heat treatment details of that repair are unknown. The metallurgical structure of the base material (carbide and gamma prime structure) have coarsened, grain boundaries are sensitized by the presence of elongated carbides and some needlelike (carbide) phases with gamma prime eutectics were observed. It appears that the metallurgical condition (carbide and gamma prime structure) has aged during operation. The primary gamma prime grown significantly at the TE (1.4 - 1.9  $\mu\text{m}$  - spherical) and somewhat grown less significantly at the LE (0.6 - 0.8  $\mu\text{m}$  - rounded), compared to the one interval buckets. Figure 5 represents the microstructure of the buckets that accumulated two intervals in the as-run condition.

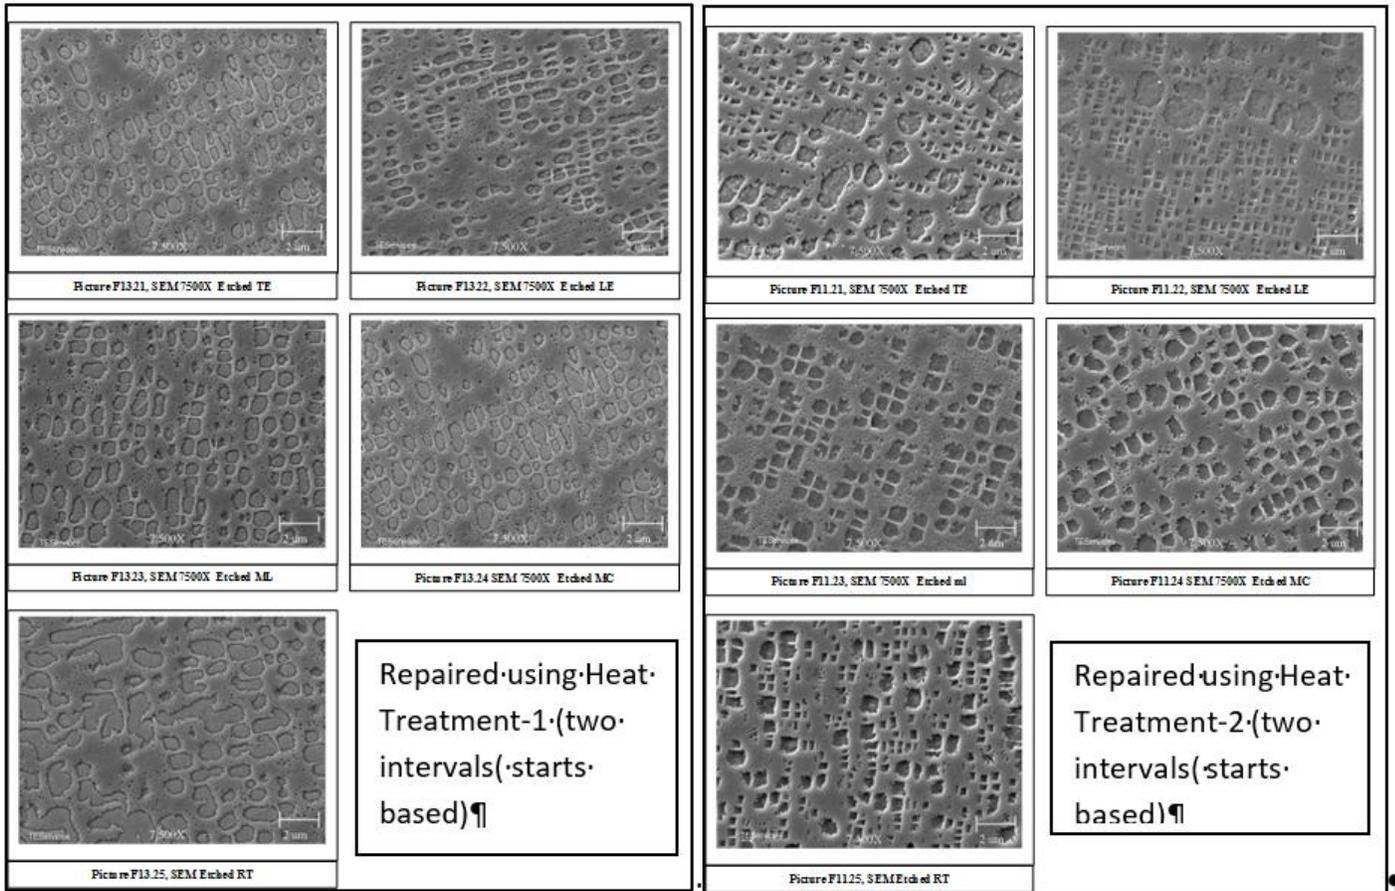
**Figure 6: Microstructure of the specimens extracted from buckets after two starts based intervals and treated with heat treatment-1 (on the left) and heat treatment-2 sequence (on the right). [Details of the sequence were listed in Table 2.]**

Scanning electron microscopy revealed significant differences of gamma-gamma prime morphology between different heat treatments. This can be seen in Figure 7 and Figure 7. Figure 7 represents the microstructure in buckets processed using heat treatment-1 and heat treatment-2, whereas Figure 7 represents the microstructure of the buckets processed using and heat treatment-3. It needs to be noted that the buckets

from the same set were selected for as-received and different heat treatments so that accurate comparison of the microstructures with different heat treatments can be performed. Higher amounts of cuboidal primary gamma prime (0.4 – 0.5  $\mu\text{m}$ ) with some spherical shaped (0.10 – 0.15  $\mu\text{m}$ ) was observed in buckets processed using heat treatment-3 sequence. The size of gamma-prime in the non-dendritic and dendritic locations was observed to be in the range of (0.4 – 0.5  $\mu\text{m}$ ), and (0.8 – 1.0  $\mu\text{m}$ ) respectively. In contrast, in the buckets heat treated using sequence 1 and 2, large rounded primary gamma prime (0.8 - 1.2  $\mu\text{m}$ ) were observed.

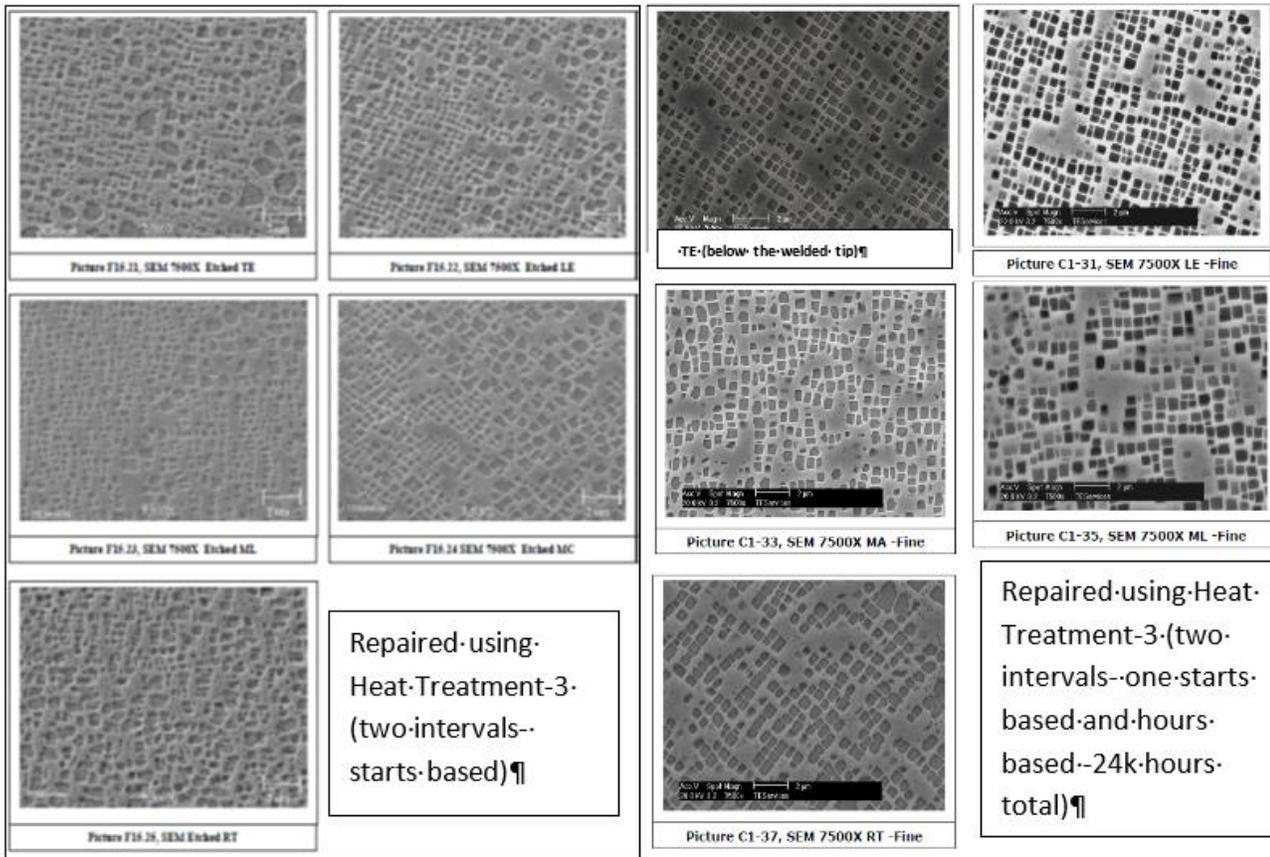
**Figure 7**  
**Microstructure of specimens extracted from buckets processed using heat treatment-2 and heat treatment-3 sequence. [Details of the sequence were listed in Table 2.]**

Microstructural investigations on repaired two-intervals buckets revealed that heat treatment-3 resulted in better morphology including refined gamma-gamma prime distribution and higher volume fraction. The average gamma prime size in heat treatment-3 is in the order of 0.4-0.5  $\mu\text{m}$  opposed to 0.8-1.0  $\mu\text{m}$  in the case of other heat treatments. In addition, heat treatment-3 resulted in smaller secondary gamma-prime size and lower volume fraction compared to the other heat treatments. Hence, it appears that heat treatment-3

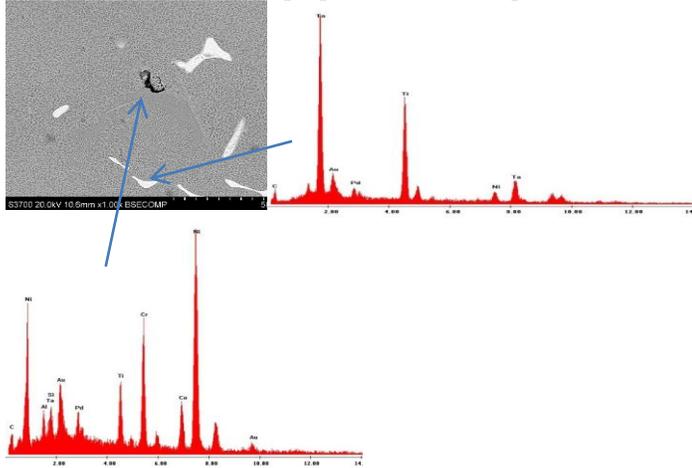
**Figure 8: EDS of Needle-like Secondary Phases Observed in the Microstructure**

As mentioned before, needle-like secondary phases observed during metallurgical evaluations were studied further. These secondary phases were also accompanied by casting defects such as inclusions. EDS analysis of the phases determined that these appear to be tantalum and titanium carbides (MC). The blocky “carbides” and other linear and X-hatched needlelike phases showed also C, Ta and Ti, however significant amount of Cr was also observed. Figure 8 represents the semi-quantitative EDS (Energy Dispersive Spectroscopy) analysis of these secondary phases.

Based on metallurgical evaluations of the 1-interval, 2-intervals and repaired buckets, these phases appear to be formed during casting and following heat treatments during the manufacturing process. It is possible that these phases grow a little during operation at the higher temperature locations (airfoil) and change (grow and reduce in size) during the repair heat treatments. These phases possibly reduce the mechanical strength of the base material during operation at that location, however it appears that the OEM has accepted the material condition and mechanical properties with these phases.

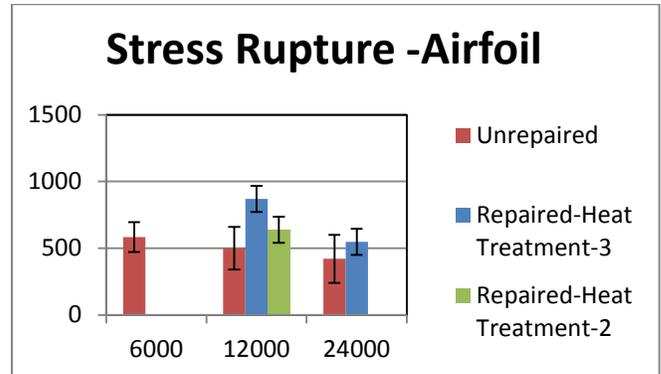
**Figure 9: Average values of stress rupture properties of specimens extracted from airfoil (Error bars represent one standard deviation)**

**Stress Rupture:** Figure 9 represents the average of stress rupture properties of airfoil specimens extracted from buckets, after accumulating 6000 (6k), 12,000 (12k), 24,000 (24k) hours of service. The buckets exposed to 12k, 24k hours have been through two service intervals which includes a repair after one service interval. One recommended service interval for the buckets equals 800 starts or 24,000 hours for a starts based operation (simple cycle) and hours based operation (combined cycle) respectively.

It appears that the stress rupture properties of the airfoil at 12k, 24k decreased with time when compared to 6k hours, due to exposure to operating temperatures for higher times as expected. On the other hand, the stress rupture properties increased significantly after repairs that involved any of the heat treatment.

However, the improvement in properties resulted from heat treatment-1 and 2 (listed as repaired-partial solution treatment) were inferior compared to the properties resulted from heat treatment-3 (listed as repaired-full solution). The increase in properties can be attributed to the more refined microstructure including increased volume fraction of gamma-gamma prime as explained in the previous sections.

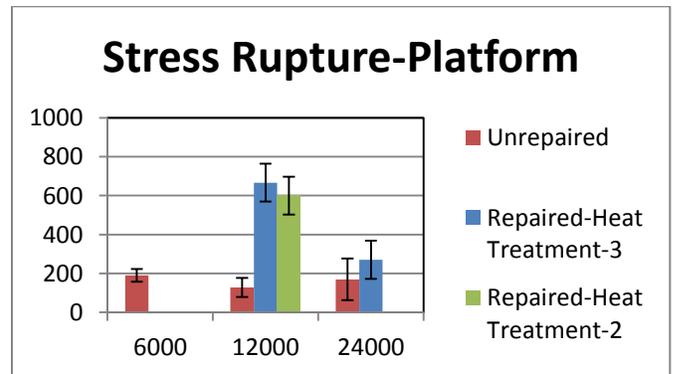
**Figure 10: Average values of stress rupture properties of specimens extracted from platform (Error bars represent one standard deviation)**

Figure 10 represents the average of stress rupture properties of platform specimens extracted from buckets, after accumulating 6000 (6k), 12,000 (12k), 24,000 (24k) hours of service. Stress rupture properties of flat specimens extracted from platform in the transverse direction revealed similar improvements from repair as the airfoil specimens. However, the improvement in properties of platform was much higher in scale for the platform specimens compared to the airfoil specimens. This can be possibly explained due to the microstructural improvements contributing more to the transverse direction than the directionally solidified airfoil. Also, the average of the platform specimens that accumulated 24k hours in the as-run condition measured higher than the average of specimens accumulated 12k hours. This can be explained based on the standard deviation in the samples and the scatter associated with the test results.

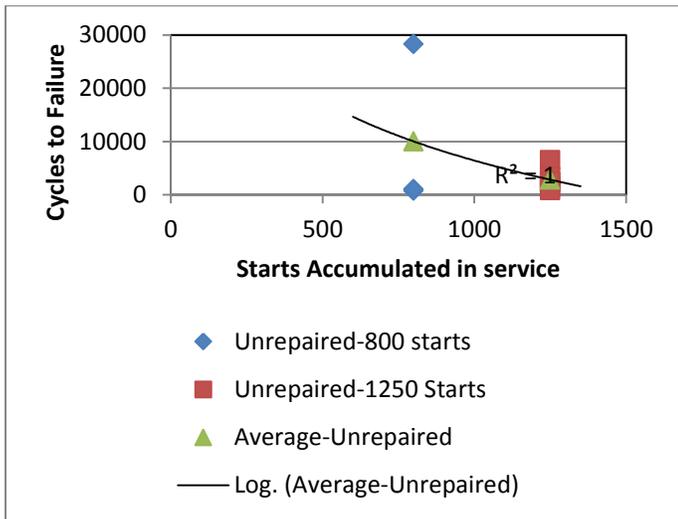
**Figure 11: LCF Life of Specimens Extracted from Platform**

Figure 11 represents the average cycles to failure for LCF specimens extracted from the platform of the buckets, after accumulating 800 and 1200 starts in service. The buckets exposed to 1200 starts have been through two service intervals which includes a repair after one service interval. As mentioned above, one recommended service interval for the buckets equals 800 starts or 24,000 hours for a starts based operation (simple cycle) and hours based operation (combined cycle) respectively. As expected, LCF properties (cycles to failure) of the platform specimens at 1200 starts decreased with time when compared to 800 starts, due to accumulation of fatigue during each and every stop.

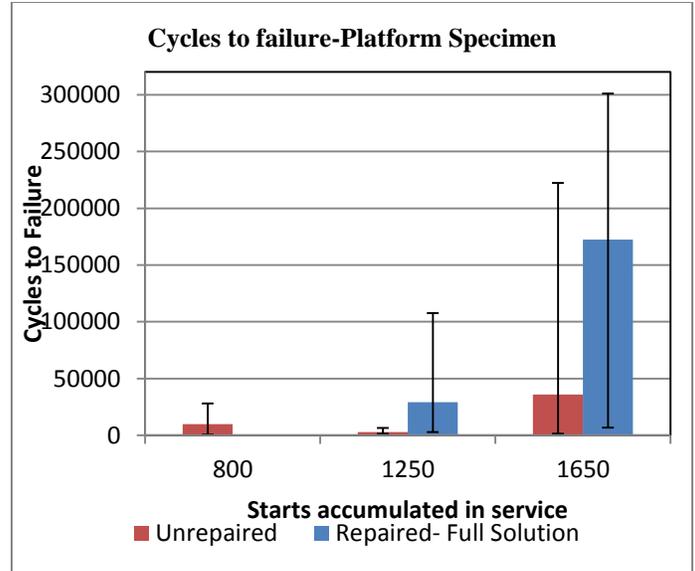
**Figure 12: Average LCF life of specimens extracted from platform [Error bars represent the range of results obtained-lowest and highest values obtained in the tests]**

Figure 12 represents the average of cycles to failure for platform specimens extracted from buckets, after accumulating 800, 1200, and 1600 starts in service in unrepaired and repaired conditions. From the chart, it appears that the specimens from buckets that accumulated 1600 starts exhibited higher average LCF life in as-run condition compared to the specimens from buckets accumulated 800 starts. This might be due to the scatter associated with the fatigue testing and it can be also seen in the range of the obtained values provided in the graph. In addition, the LCF properties increased significantly after repairs. The repairs performed on the buckets involved the heat treatment-3 as listed in Table 2, which included HIP and full solution. This might be related to the refined microstructure observed in the samples with that heat treatment.
