HOT SECTION LIFE MANAGEMENT THROUGH IMPROVED MATERIAL PROPERTY RECOVERY

John Scheibel/ Electric Power Research Institute, **Rajeev Aluru**/ Duke Energy,
Hans van Esch, Stijn Pietersen/ Turbine End User Services

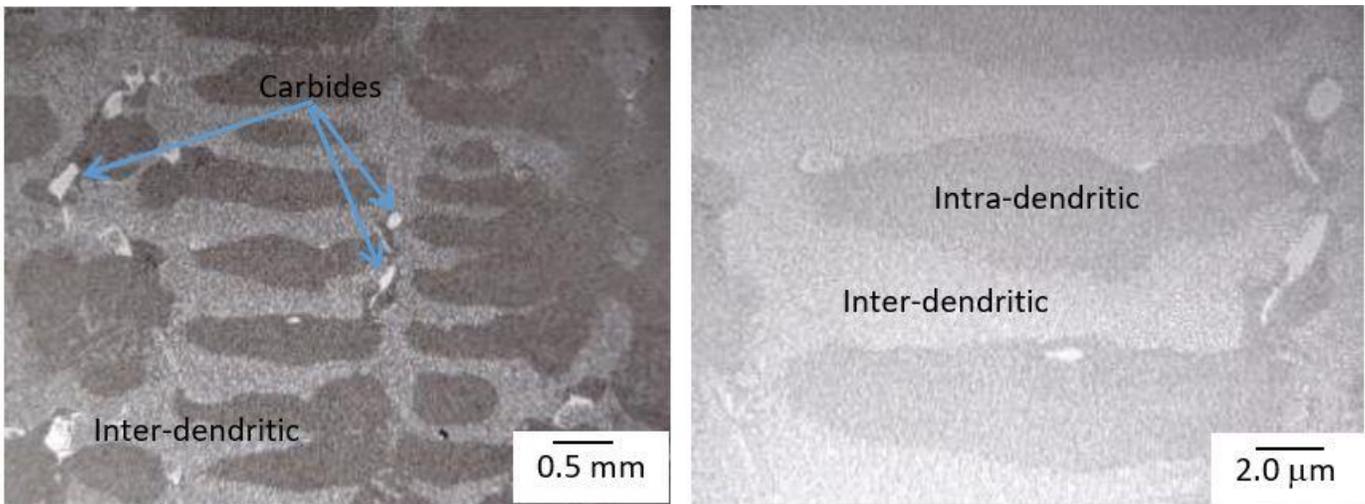
Scanning electron microscopy of the same sections was performed to study the gamma-prime morphology and distribution. Figure 3 provides representative detail on the inter-dendritic (outside the dendrite arm) and intra-dendritic (inside the dendrite) regions for reference. Figure 4 represents the microstructure of the bucket in as-run condition. The morphology appears to be different between inter-dendritic and intra-dendritic regions. The primary gamma prime of the inter-dendritic regions appear to be smaller and more cuboidal of shape than intra-dendritic regions. The size of gamma-prime was compared across different regions and the root section was assumed to be the baseline. The primary gamma prime at the TE was rounded and had grown significantly (1.0 - 1.8 μm , spherical), and the growth was somewhat less significant at the LE (0.7 - 1.2 μm , spherical / rounded). At the mid airfoil cross and longitudinal sections, the size of the primary gamma prime (0.7 - 1.0 μm , rounded) was just a little larger than the root (0.6 - 1.0 μm , rounded / cuboidal) and maintained almost the same shape compared to the root. The secondary gamma prime was mostly not present at the TE, less present at the LE and about the same size (0.10 - 0.20 μm) and shape (spherical) at the mid airfoil and root.

Figure 3
Representative Micrograph Showing Inter-dendritic and Intra-dendritic Regions. The picture on left shows dendritic microstructure and the one on right shows more detail on the difference in gamma-prime.

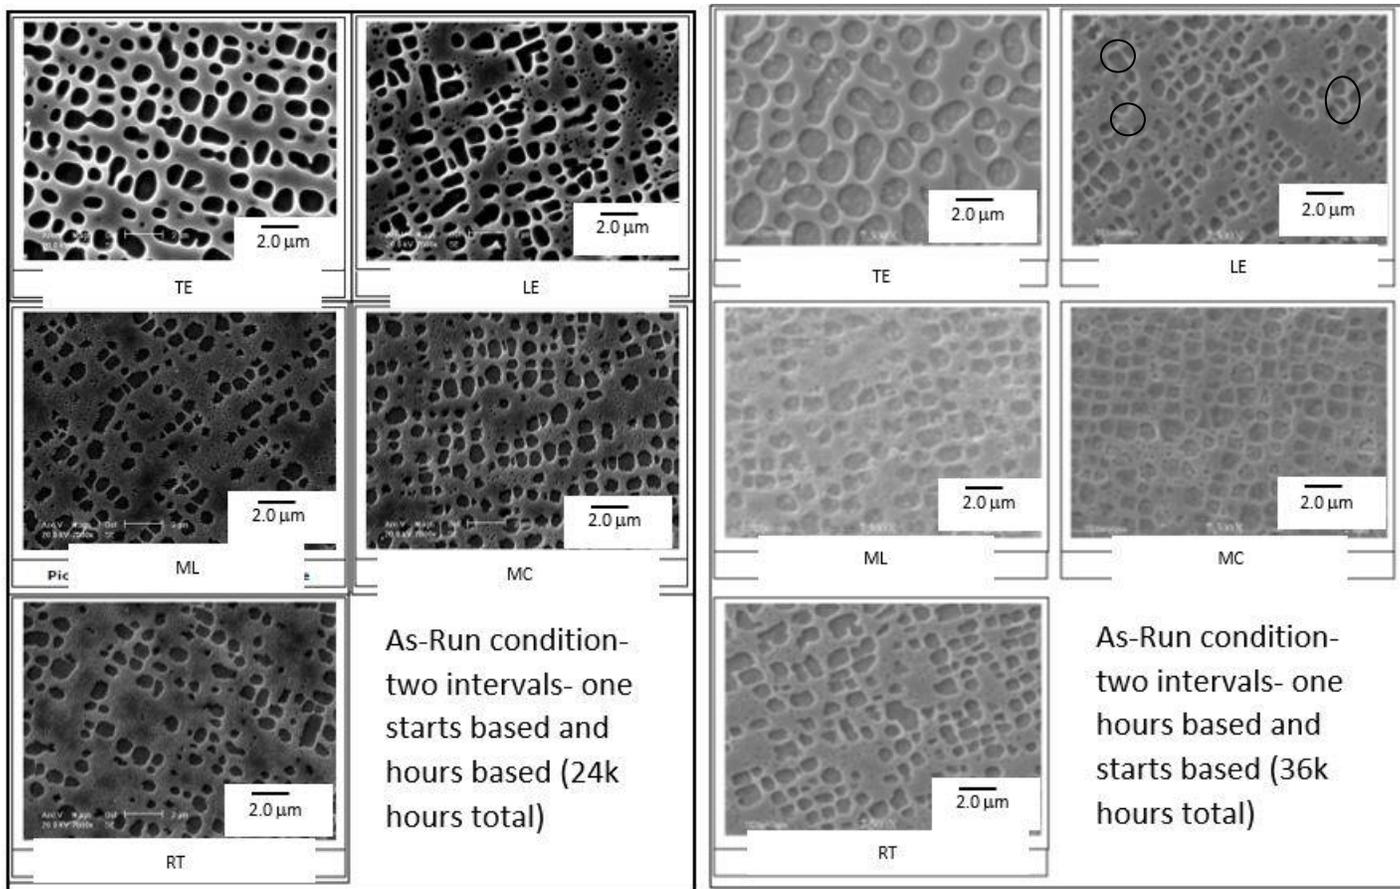
Figure 4

This section refers to the evaluation of the group of buckets that accumulated two service intervals with a repair after its first cycle. The heat treatment details of that repair are unknown. The metallurgical structure of the base material (carbide and gamma prime structure) have coarsened, grain boundaries are sensitized by the presence of elongated carbides and some needle like (carbide) phases with gamma prime eutectics were observed. It appears that the metallurgical condition (carbide and gamma prime structure) has aged during operation. The primary gamma prime grown significantly at the TE (1.4 – 1.9 μm - spherical) and somewhat grown less significantly at the LE (0.6 – 0.8 μm – rounded), compared to the one interval buckets. Figure 5 represents the microstructure of the buckets that accumulated two intervals in the as-run condition.

Microstructure of the Specimens Extracted from Buckets after Two Intervals-one starts based and on hours based in As-run Condition [buckets accumulated 24k total hours on the left and the ones accumulated 36k total hours on the right]. Details of sample locations are listed in Table 3.

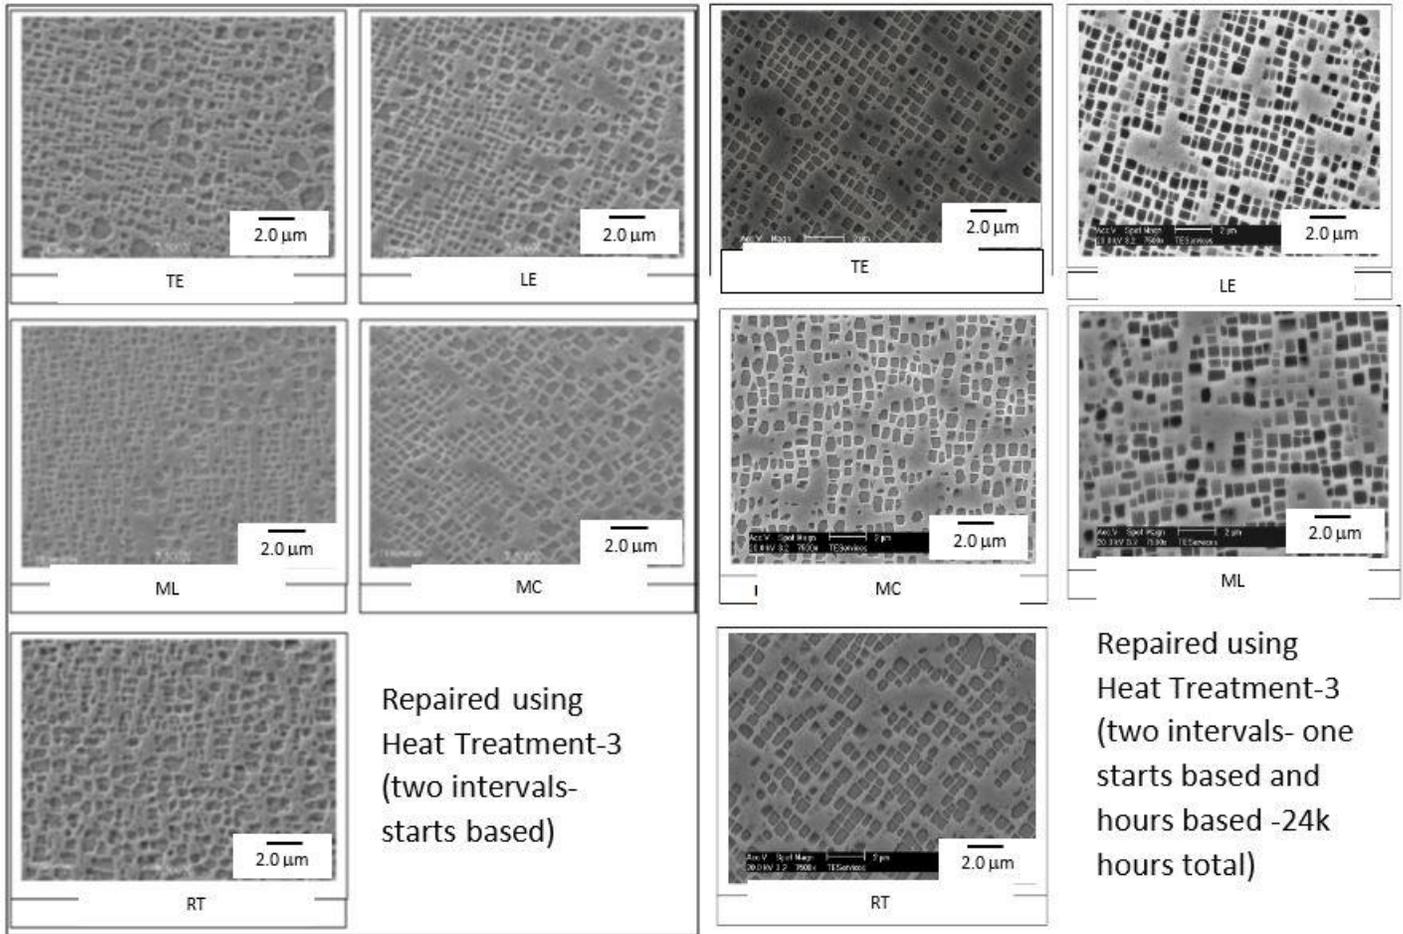
Microstructural investigations on repaired two-intervals buckets revealed that heat treatment-3 resulted in better morphology including refined gamma-gamma prime distribution and higher volume fraction. The average gamma prime size in heat treatment-3 is in the order of 0.4-0.5 μm as opposed to 0.8-1.0 μm in the case of other heat treatments. In addition, heat treatment-3 resulted in smaller secondary gamma-prime size and lower volume fraction compared to the other heat treatments. Hence, it appears that heat treatment-3 results in an optimized microstructure similar or better than the original condition. This size distribution and the possible impact of the microstructure on mechanical properties will be discussed in the next section.

Figure 6
Microstructure of specimens extracted from buckets processed using heat treatment-2 and heat treatment-3 sequence. Details of the sequence are listed in Table 3.

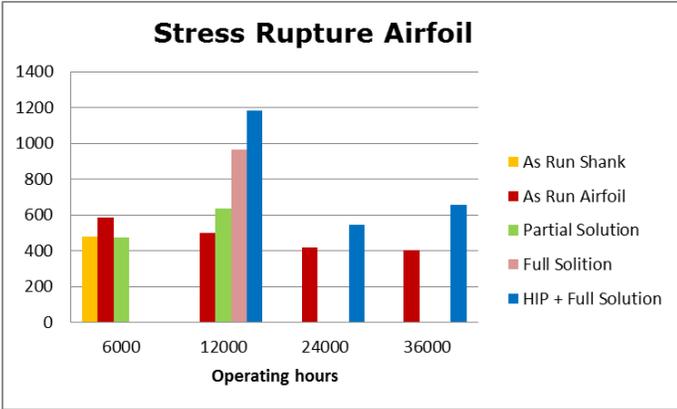
The stress rupture testing results of the partial heat treatment specimens at 6000 hours are comparable to the As Run results. (As Run is the condition after operation without heat treatment performed). This indicates that this heat treatment does not positively or negatively change the stress rupture life, see Figure 9. The heat treatments HIP + full solution, full solution and partial solution do result in increased stress rupture lives for the 12000 hours specimens compared to As Run and even new. This indicates that the heat treatments performed at new manufacturing were not optimal.

Figure 7
Average values of airfoil specimen stress rupture strength

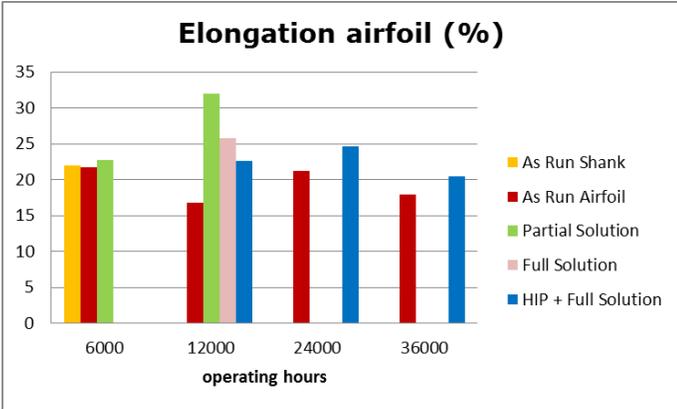
The elongation and RoA (Reduction of Area) of the stress rupture samples are taken as a measurement of the ductility. All ductilities were between 16.8% and 24.6% and thus no significant differences for all the different operating conditions and heat treatments were observed. See Figure 10 for the elongation and Figure 11 for the RoA. An exception is the elongation for the 12000 hours specimen with the partial solution heat treatment which averaged 32% while HIP + full solution average 19%. This can be due to the heat treatment performed or just an outlier due to the low number of tests performed.

Figure 8
Average values of stress rupture elongation airfoil specimen

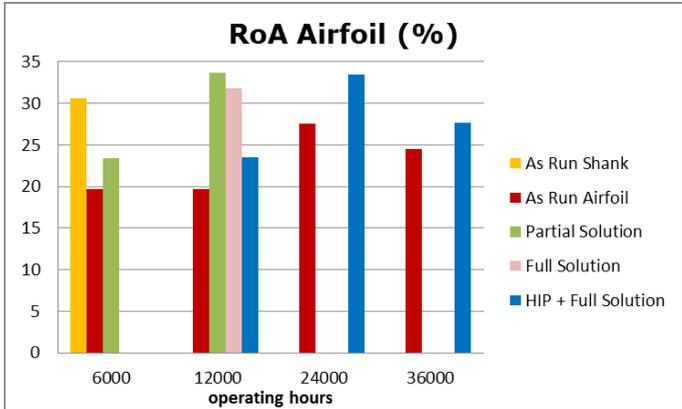
Figure 9
Average values of stress rupture RoA airfoil specimen

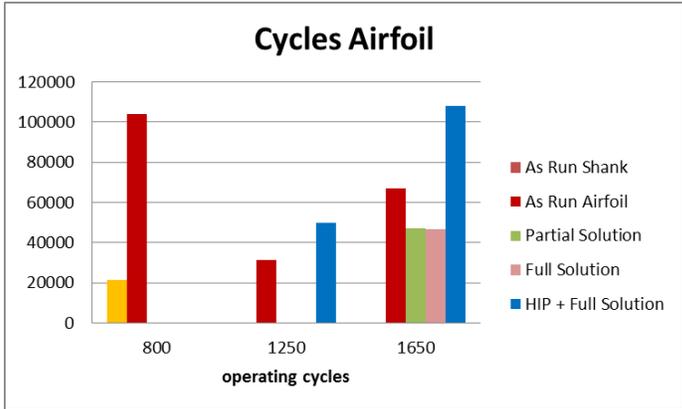
For the 1650 cycle specimens, the partial solution and the full solution heat treatment results in a lower LCF life (although higher than was measured for 1250 cycle As Run), while the HIP + full solution heat treatment increased the LCF life, see Figure 12.

The root specimen (new) LCF lives of the one interval (800 cycles with 6000 hours) are lower than the airfoil specimens of the as run material (exposed). This was not observed in the stress rupture testing where the result for the root and airfoil were comparable. The differences in LCF can be due to the casting differences in the root (direction grains).

Figure 10
Average LCF life of airfoil specimens

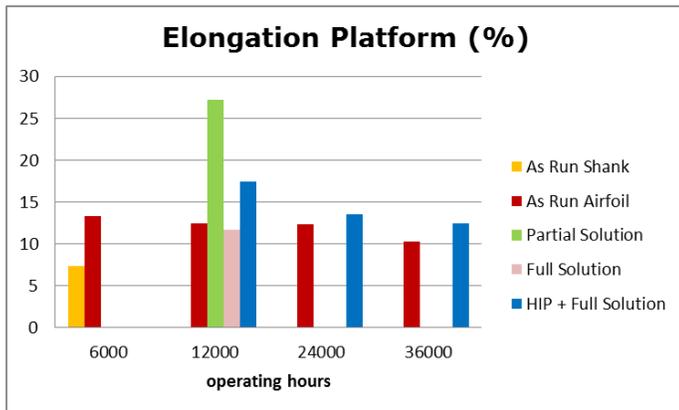
There are no substantial differences between the ductility for full solution and HIP + full solution heat treatments for the platform specimens which were between 10.3% and 17.4% for elongation and 10.2% and 19.5% for RoA, see Figure 15 for the elongation and Figure 15 for the RoA. The partial solution heat treatment has a ductility about twice (average 27.2% versus 11.7%) that of the full solution heat treatment for the specimens that have ran for 12000 hours. This high ductility cannot be observed for the RoA.

Figure 11
Average values of elongation of stress rupture tests platform specimens

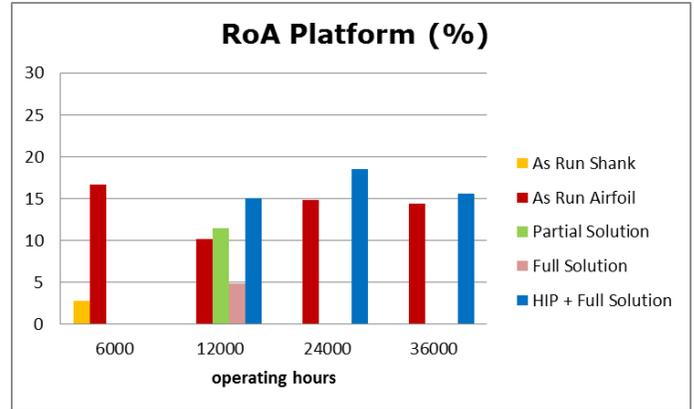
Figure 12
Average values of elongation of ROA of stress rupture tests platform specimens

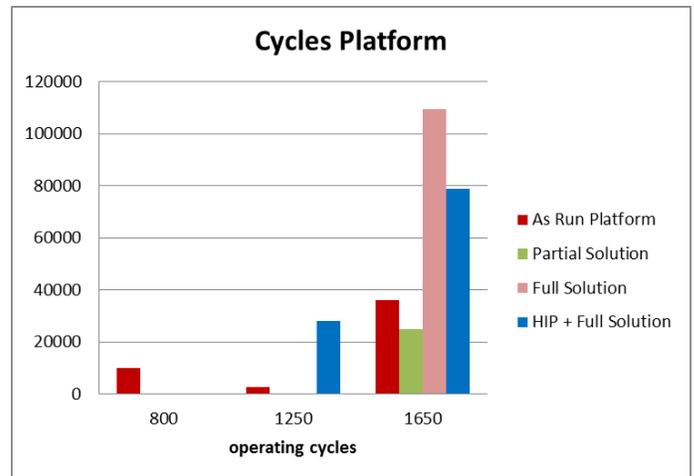
For the 1650 cycles platform specimens, full solution heat treatment gave the best LCF life, followed by the HIP + full solution heat treatment and the partial solution heat treatment, see Figure 16. Note: The partial solution heat treatment results were lower than the As Run LCF tests. The number of test specimens was limited and the LCF data also showed a significant scatter and therefore more LCF testing is required to substantiate above observations.

Figure 13
Average LCF life of specimens extracted from the platform
